THESIS

**POWER PLANT AND
DRIVE TRAIN IMPROVEMENTS
OF THE
NPS *HUMMINGBIRD*
REMOTELY PILOTED HELICOPTER**

Robert E. Conway

September, 1996

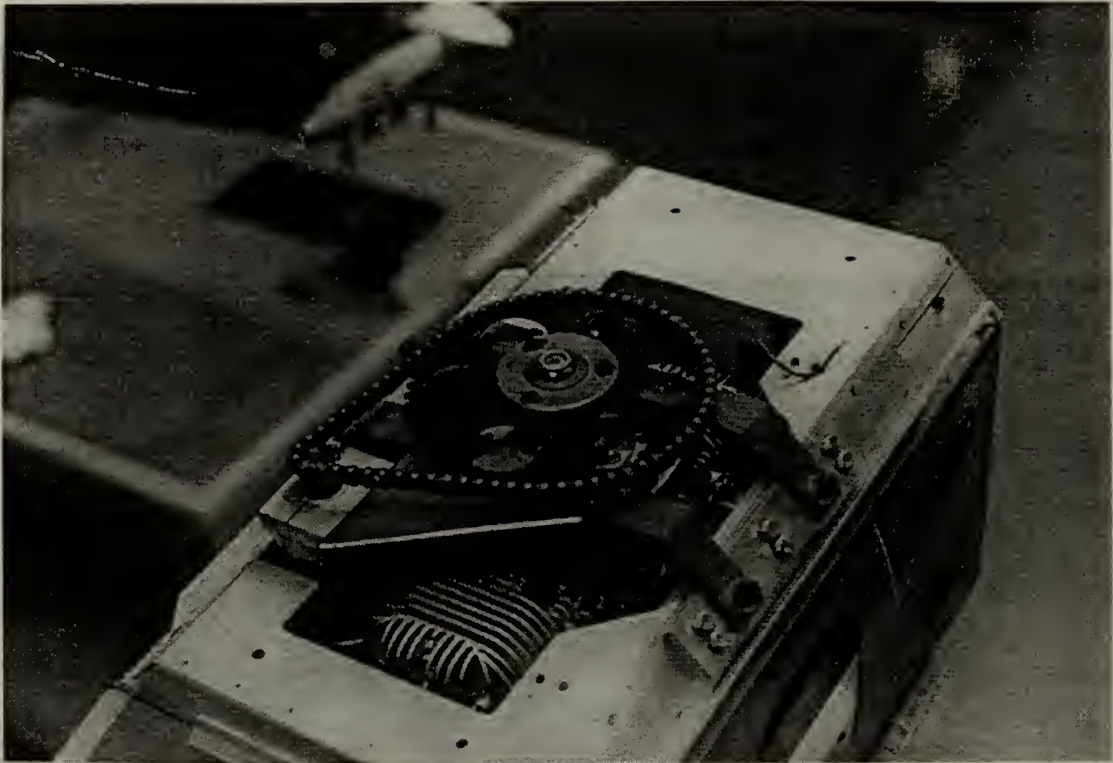
Figure 1. Original Starting System Configuration

The original starter was a permanent attachment to the *Hummingbird*. The starter motor was a 12 volt electrical motor which was hard-mounted to the airframe close to the forward engine cylinder. The starter motor shaft was fitted with a 1 inch diameter sprocket which drove another 7 inch sprocket through a chain drive providing a 7:1 mechanical advantage for the starter motor. A one-way bearing on the 7 inch sprocket provided for starting force in the counterclockwise direction and freewheeling in the clockwise direction as viewed from the top of the RPH. Two DC power cables ran from positive and negative cable receptacles in the left side of the forward fuselage to the starter motor. Figure 1 shows this configuration.

The starter motor was found to be under powered. Prior starting attempts required two fully charged 12 volt marine batteries connected in series (24 volts total) for the electric motor to provide enough starting torque to the engine. This configuration ran the risk of burning out the starter motor and causing an electrical fire on the airframe.

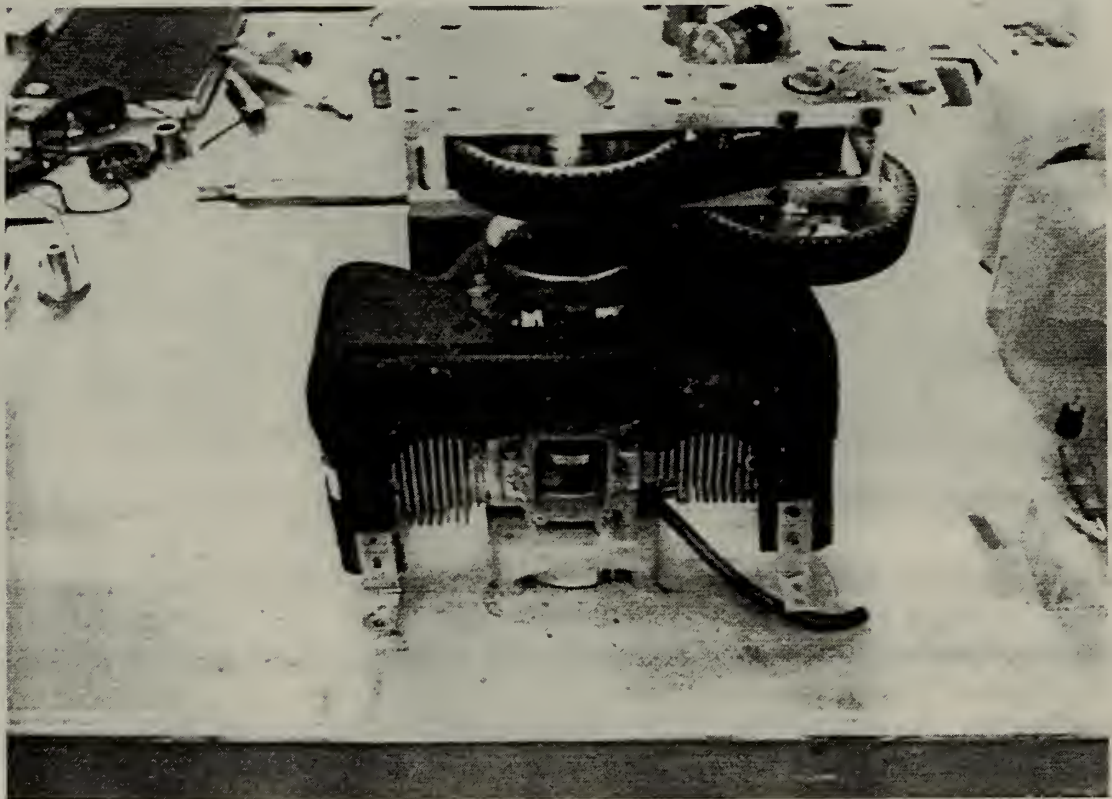
Figure 2. Layout of Engine Cooling Components

The configuration of the engine-cooling system was as follows. A 6 inch diameter vane-axial impeller was mounted to the engine drive shaft which rotated at speeds between 3000 and 7000 rpm. A crudely manufactured cowling was installed over the engine and impeller with the top of the impeller exposed just above the cowling. The cowling was constructed of fiberglass and fit closely around the engine. A make-shift diffuser, similar to those found in smaller scale model helicopter cooling systems, was molded into the top

of the cowling to provide an increase in pressure to reduce losses in the system. The air was directed out the bottom of the fuselage and into the atmosphere. Figure 2 shows the layout of the cooling system components.

The original design of the *Hummingbird's* engine-cooling system was proven inadequate by failure of the engine due to overheating. The engine manual states that the maximum cylinder head temperature measured at the spark plug gasket is not to exceed 482° F and maximum exhaust gas temperature is not to exceed 1022° F. Upon inspection of the

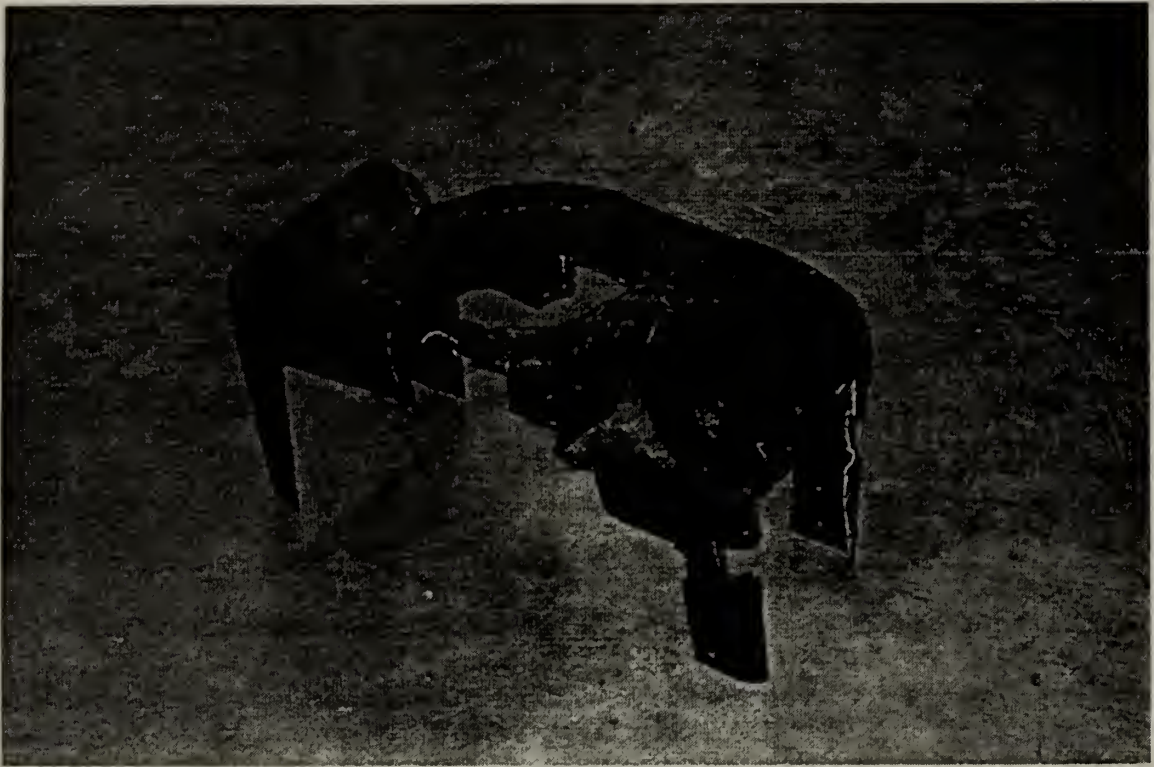
Figure 3. Existing Engine Cooling Cowling

The “cooling air-flow” was insufficient for the following reasons. First the cooling system was designed to draw air in to the center of the engine and then to direct it out along the cylinder. The cooling fins were perpendicular to the direction of flow causing the airflow to be disrupted as it moved further away from the center of the engine. Sufficient airflow to the cylinder head was therefore not available. A significant amount of the fiberglass cowling that directed the airflow over the engine had also been trimmed away to accommodate the starter and exhaust components. In order to mount the starter an approximately 3x5 inch square had to be removed. Other cut-outs for the engine exhaust, decompressors (small ports mounted on both cylinder barrels to aid in engine ignition) and mounting hardware, shown in Figure 3, had widdled away at the intended design rendering this component ineffective.

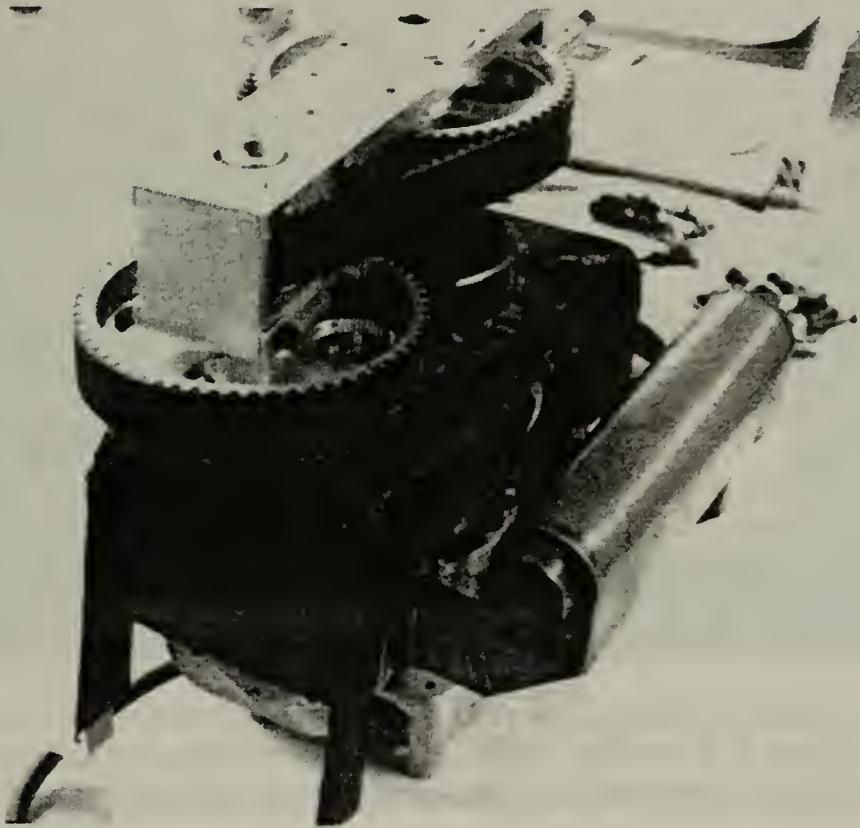
Figure 4. Exhaust Manifold Position

fuselage interior during ground runs aside from an insignificant amount of main rotor wash. The exhaust manifold was also positioned just 2 inches from the intake of the cooling fan as seen in figure 4.

The result was an intake of cooling air with an equal or higher temperature than the maximum cylinder head temperature.

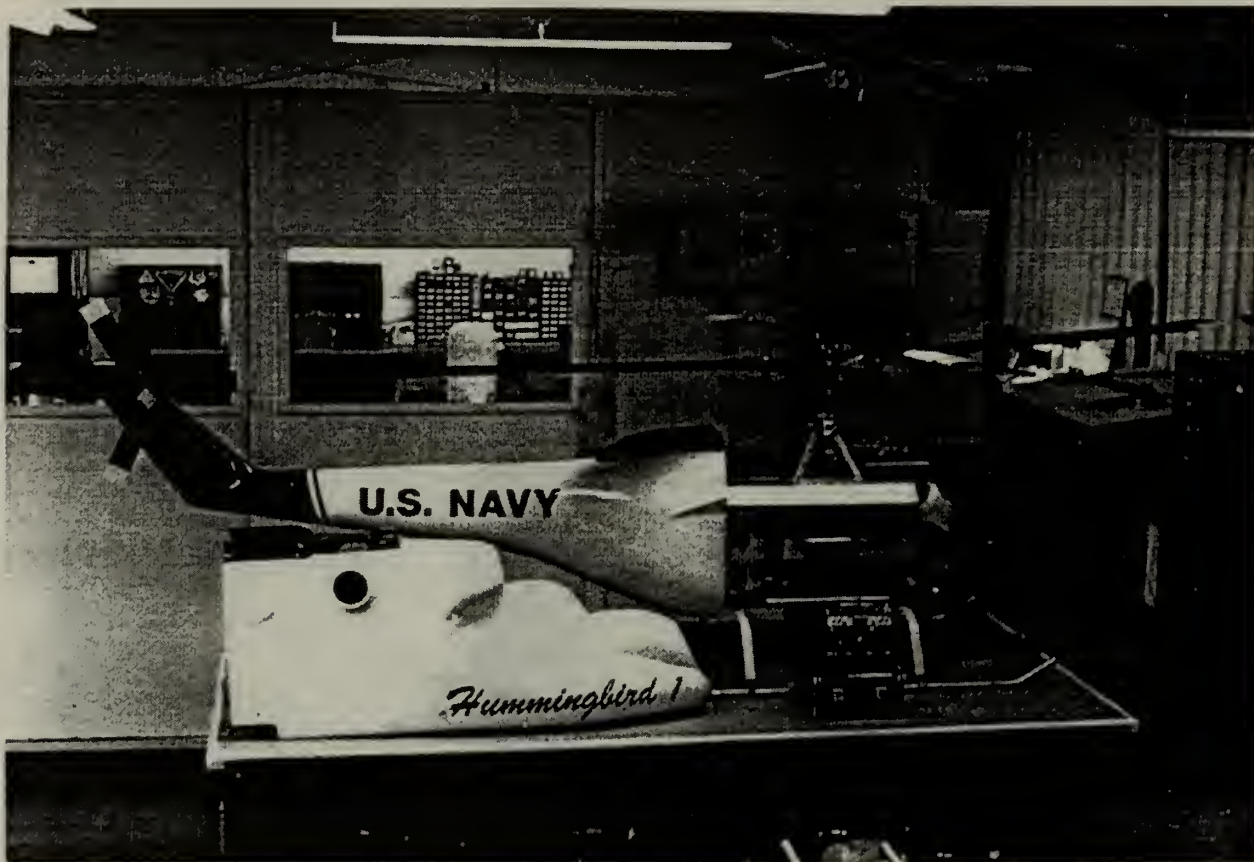
Prior ground tests of the *Hummingbird* at NPS were conducted with the fiberglass front body shell off to allow the maximum heat dissipation and ventilation possible. Photographs of RPH's similar to the *Hummingbird* show ventilation holes cut in both sides of the front body shell. The *Hummingbird*, however, only had one hole cut in the left side. Figure 5 shows a right side view of the RPH with no ventilation hole cut in the fiberglass

Figure 5. Right Side View of *Hummingbird* Without Ventilation Port body shell and the exhaust manifold's position just inside the fuselage. The solid fiberglass shell on right side allowed a build up of the exhaust manifold temperature which could have further increased the cooling air temperature at the intake of the cooling fan. The object seen in the hole in the fuselage in Figure 6 is the exhaust manifold.

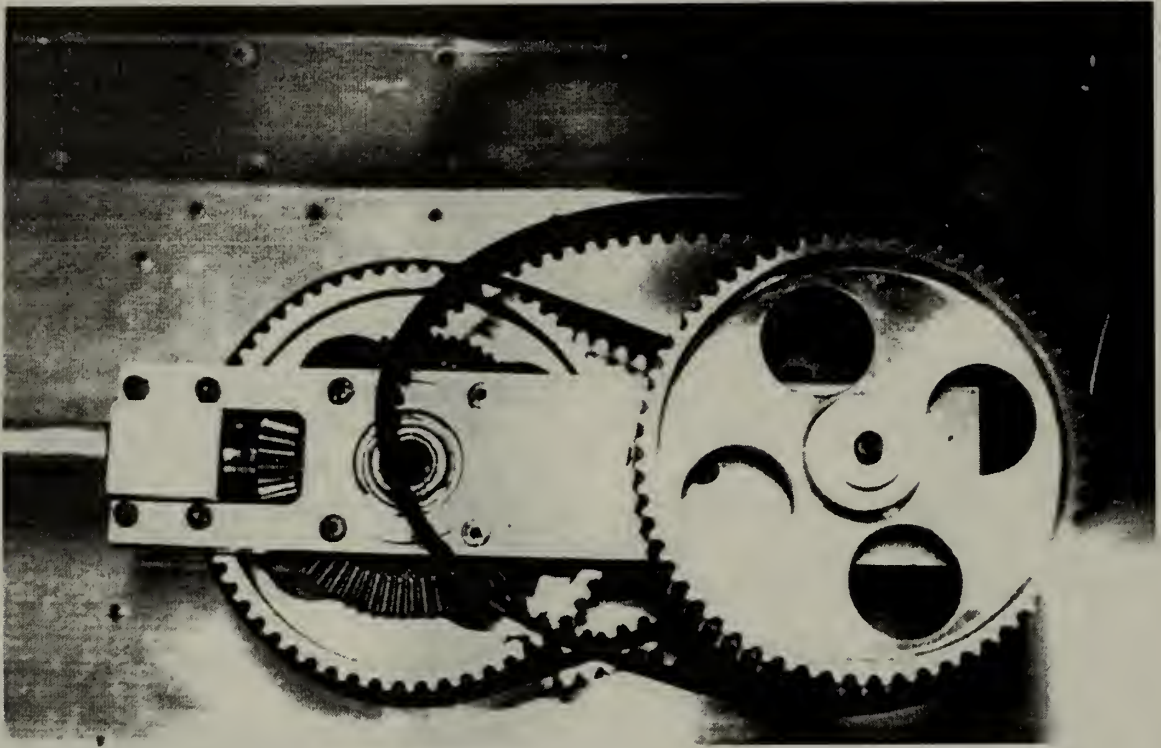
Figure 6. Main Transmission

The drive train begins at the engine drive shaft. The vane-axial cooling fan and centrifugal coupler were mounted on a shaft extension and a drive pulley is attached to the top of the centrifugal coupler. A drive belt connects this pulley to an intermediate shaft to which a sprague clutch is mounted for autorotational capability. Another belt drive is connected to a pulley which is keyed to the main rotor shaft. The tail rotor take-off is driven by bevel gear mounted to this pulley. Total gear reduction is 10:1 from the engine to the main rotor shaft and 3.2:1 to the intermediate shaft. The tail rotor drive shaft turns at 40% of the engine shaft speed. Figure 6 shows the main transmission layout.

As mentioned in the background investigation chapter, massive torque fluctuations due to unsteady idle speeds exist. These torque fluctuations were reported to, however unverified, snap the main rotor shaft of a similar RPH. In any case, fluctuations in engine torque are magnified ten times at the main rotor shaft due to the 10:1 mechanical advantage given by the transmission. With the exception of the hard rubber belts and limited slipping in the centrifugal coupling, there is nothing to absorb any sort of shock caused by torque

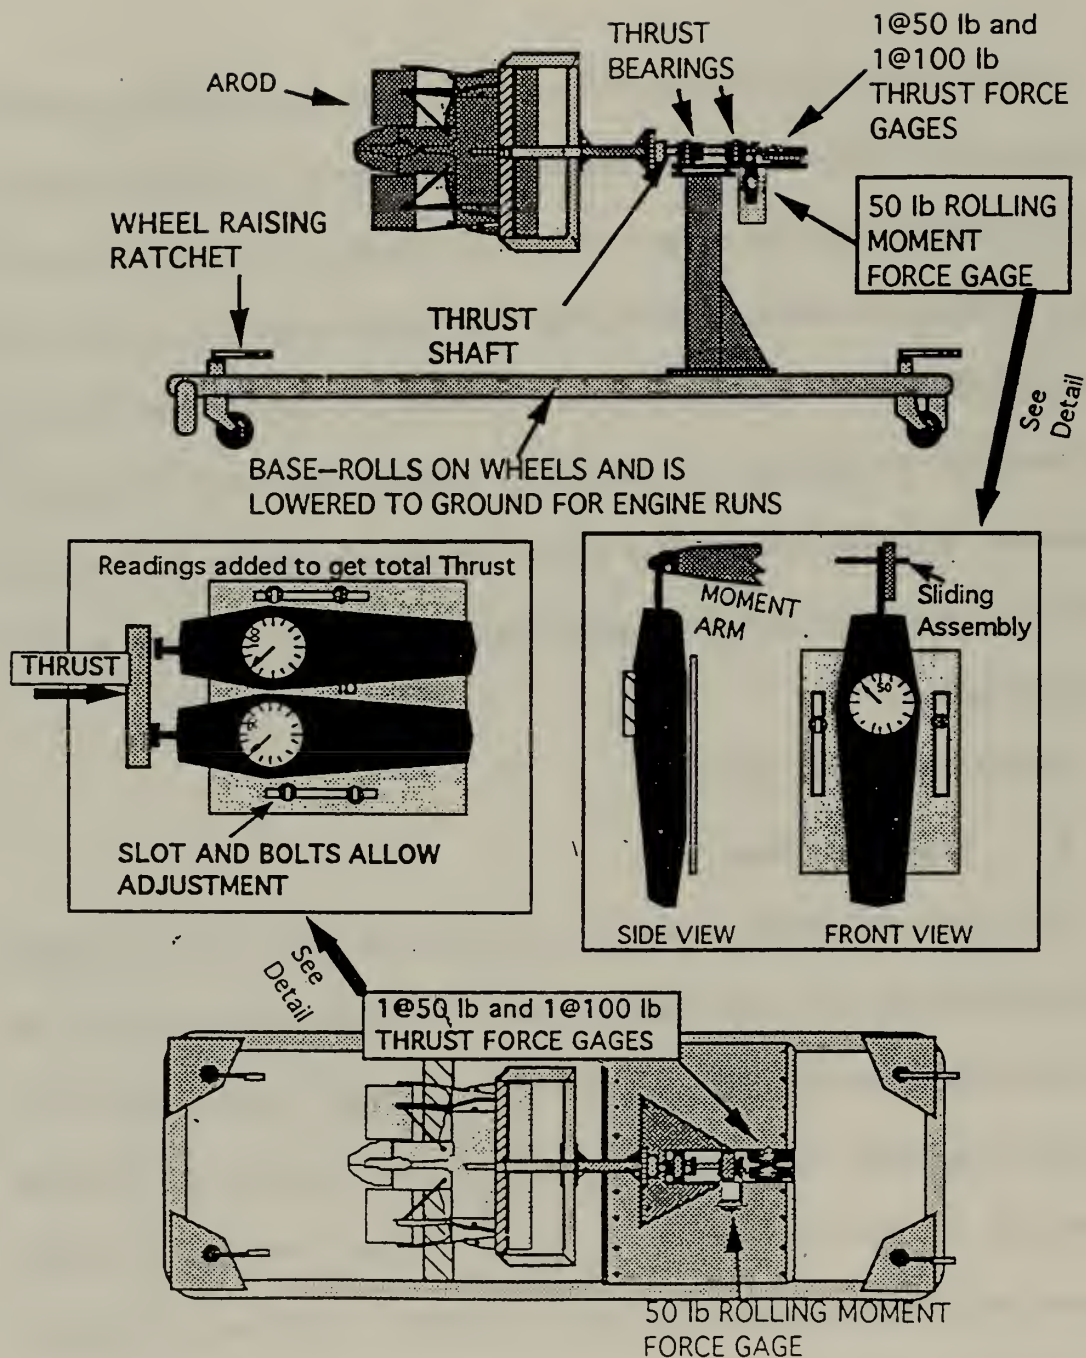
Figure 7. Engine Test Apparatus

The engine was mounted on a test stand designed to measure thrust and rolling moment of the AROD UAV. The rolling moment was the only measurement taken and allowed the determination of engine power. Thrust measurements were not needed for the performance calculations. The moment was computed by reading a force gage which was mounted at the end of a 9 inch moment arm, as seen in Figure 7, and then converted to horsepower after obtaining engine rpm by a strobe tachometer. To provide a working load during the testing and break-in procedures a 30 inch diameter birch propeller (commonly used in ultra light aircraft applications) was installed. Figure 8 shows the engine rigged for testing. The direction of rotation of the engine was opposite to the direction of rotation of

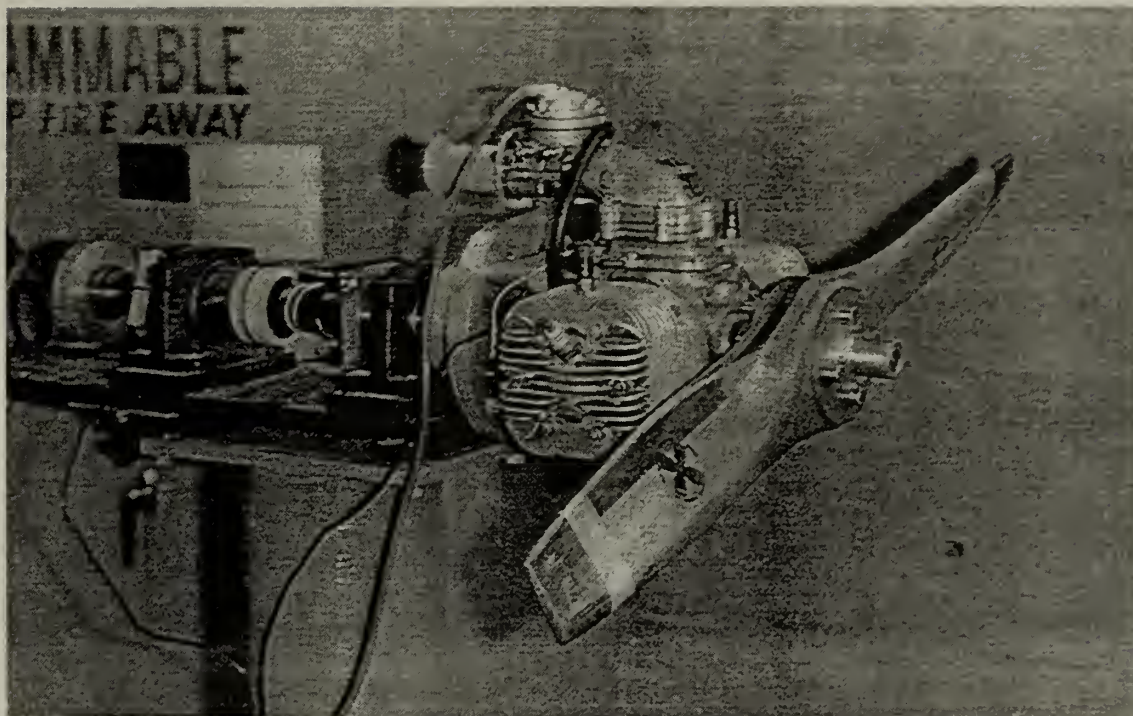
Figure 8. Wael 342 in the Test Configuration

the propeller. For this reason the propeller had to be mounted backwards. A one gallon fuel tank provided a 25:1 fuel-oil mixture to the engine. As a precaution a 24 inch diameter room fan was placed to direct airflow over the engine. This later proved to be ineffective.

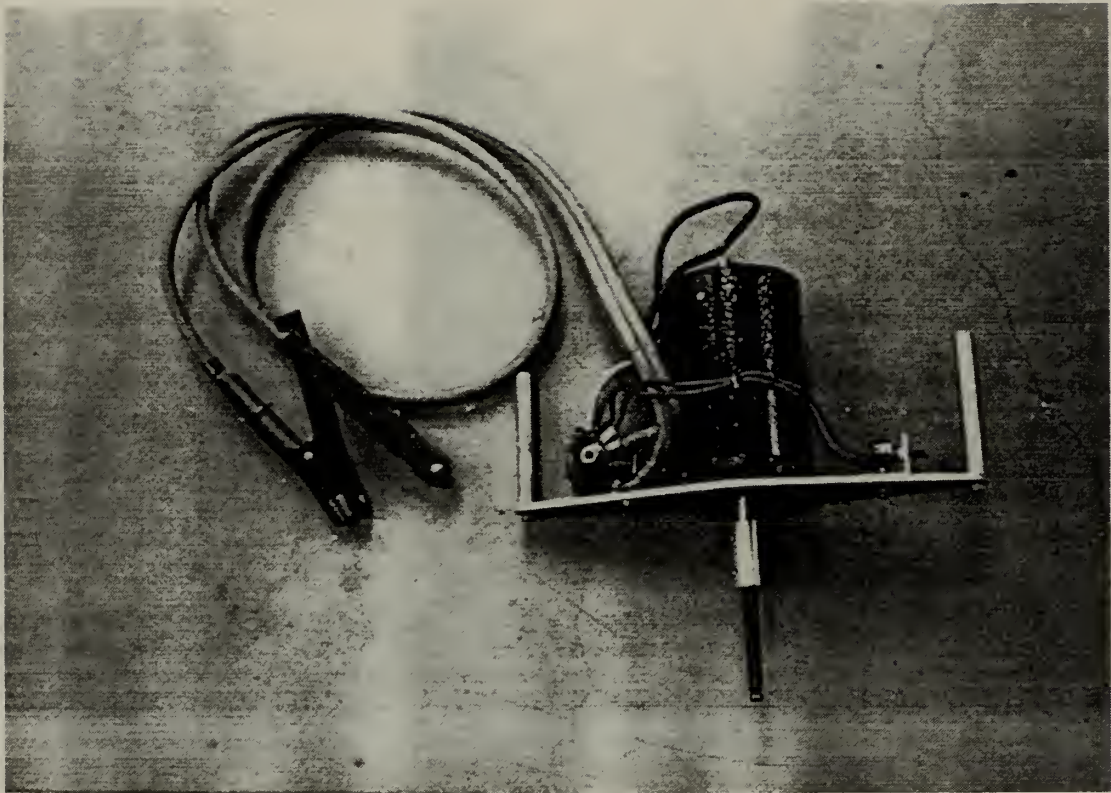
Figure 9. Hand-held Starter

The engine was started by a hand-held starter which contained a new starter motor shown in figure 9. With the need to start the engine in a counter-clockwise viewing the engine from the rear on the test stand, a starter with this rotation was sought. Also at this

stage of the research the direction of rotation of the external starter design had not yet been decided. Therefore a starter with the capability of providing adequate torque in both directions was prudent. The Prestolite MBJ-4407 winch motor was chosen for its availability, power and dual directional capability. The performance specifications for this motor can be found in appendix C.

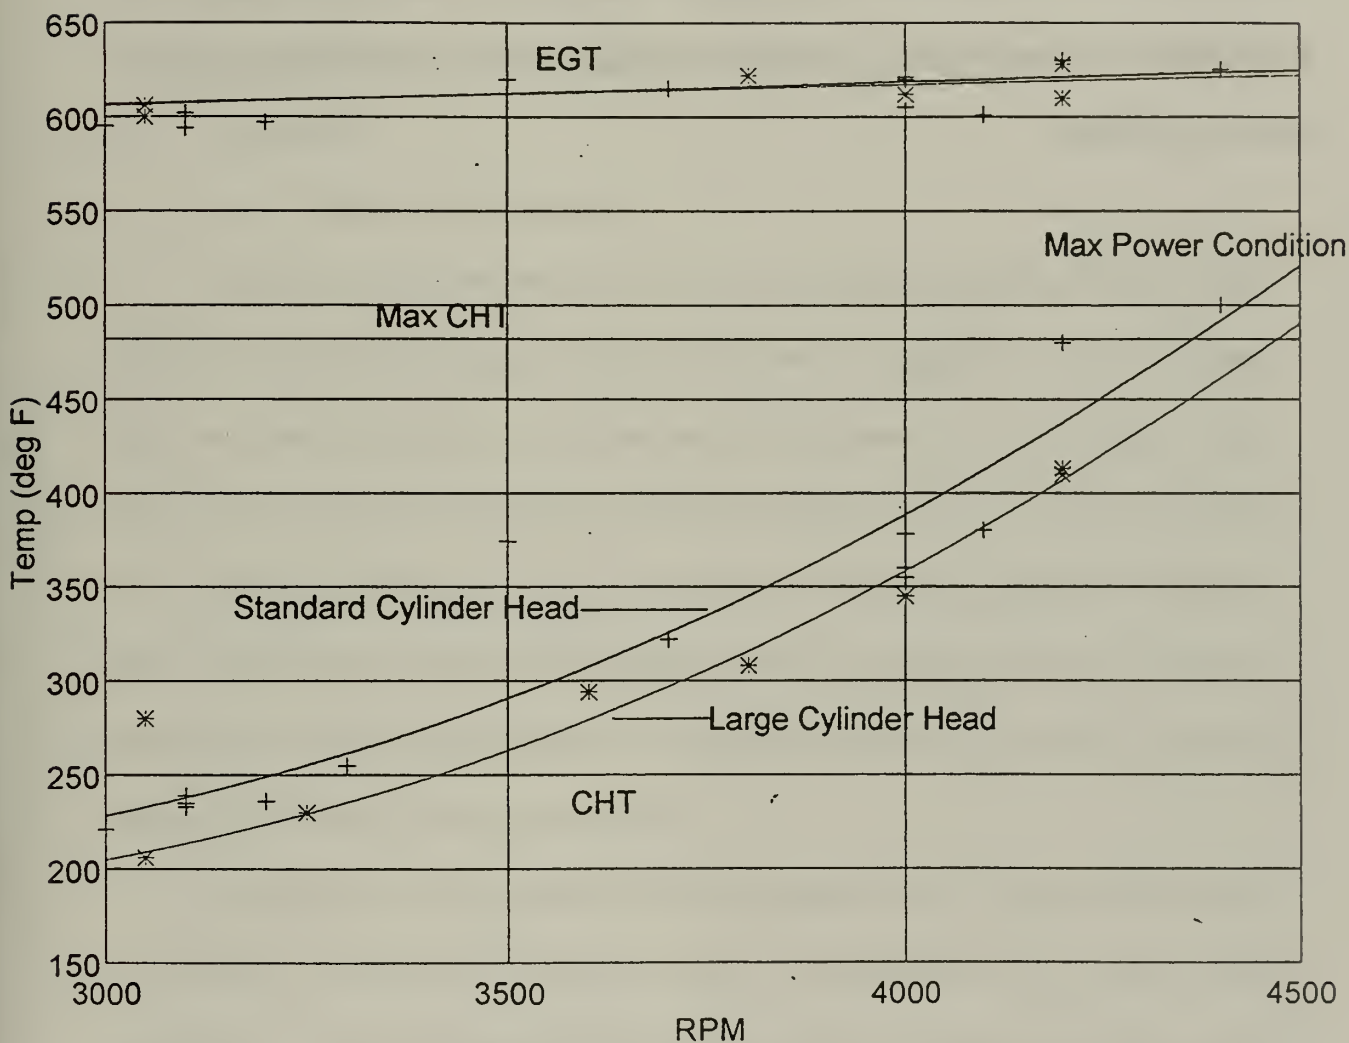
Figure 10. CHT Comparison for Large and Small Cylinder Heads

The engine was again tested in static air conditions. Runs initially at idle power settings showed an approximate 25°F decrease in CHT and, as expected, no change in EGT. Runs at maximum throttle showed a maximum CHT of 435°F. The effect of the increased

area of the cylinder head reduced the maximum CHT by over 47°F in static conditions. A comparison of the EGT and CHT observed with the two sizes of cylinder heads is shown in Figure 10.

This determination moved the cooling system design away from a high mass flow system to an interior ventilation or low mass flow system in which the induced air flow velocities over the engine on the test stand would be matched or increased inside the fuselage.

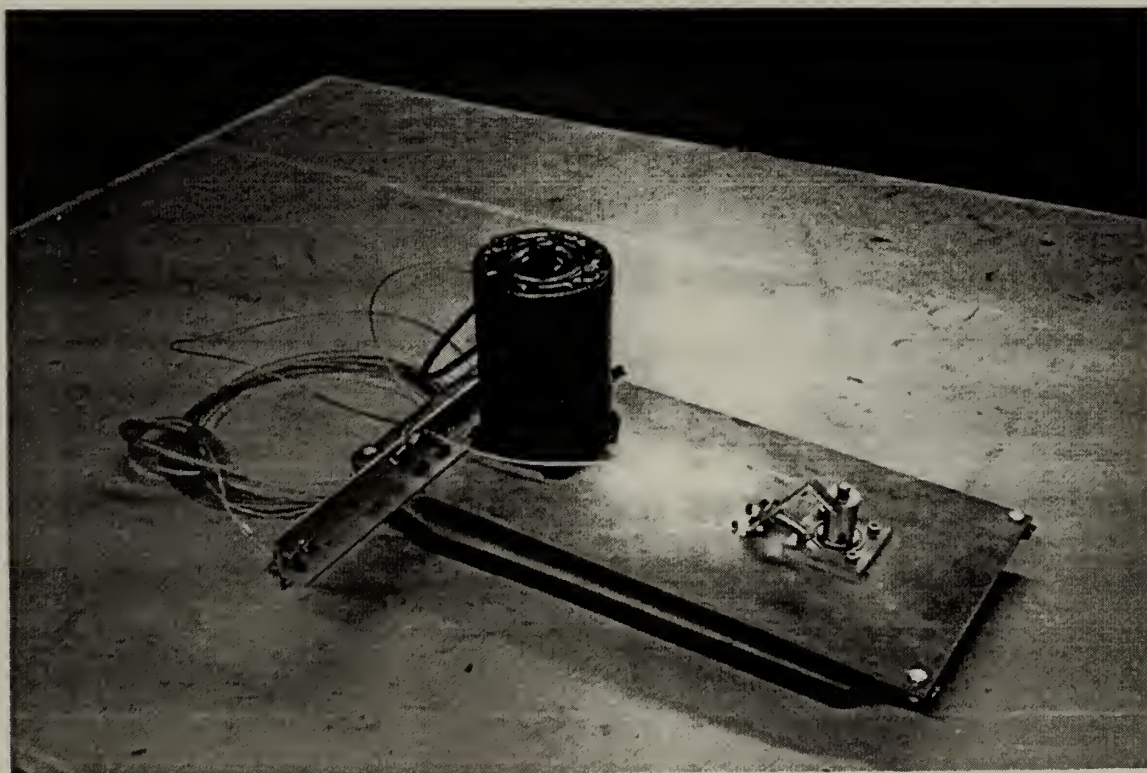
Figure 11. Top View of Starter

The starter assembly's final design is as shown in Figures 11 and 12. It consists of a 0.25" x 9" x 20" base plate to which the driving components are mounted. The starter motor is the 12 volt Prestolite MBJ-4407 winch motor used in the hand held starter. A 1:1 drive ratio was proven effective by the hand held starter during the engine tests. Originally

the motor was mounted as follows. The starter motor mounts to the plate with the drive shaft passing through the plate from top to bottom. A 7 inch sprocket taken from the spare *Hummingbird* parts is mounted to the end of the shaft. An insert for the sprocket had to be designed and manufactured to replace a one-way bearing of the original design to eliminate any slippage. A chain drives another 7 inch sprocket which is mounted to the engine starting drive shaft. This sprocket contains a one way bearing which allows for torque application during start and freewheeling when the engine rpm exceeds the starter rpm. The original insert for the one way bearing was designed for the tapered shaft that mounted to the bottom of the engine by means of friction only which caused some damage due to metal-to-metal

slippage. A new piece was designed and manufactured to accommodate a straight shaft and key. The sprocket is attached to the drive shaft which passes upward through the plate. A 3/8 inch hex-ball drive wrench is pressed into an adapter which rides on a thrust bearing to prevent excessive wear of the starter drive shaft components. The ball drive wrench again gives the benefit of allowing small misalignments which occur during engine start and allows the starting assembly to drop free of the structure without jamming in the drive socket. The thin neck of the wrench is also the most convenient place for the starter to structurally fail should normal starting forces be exceeded.

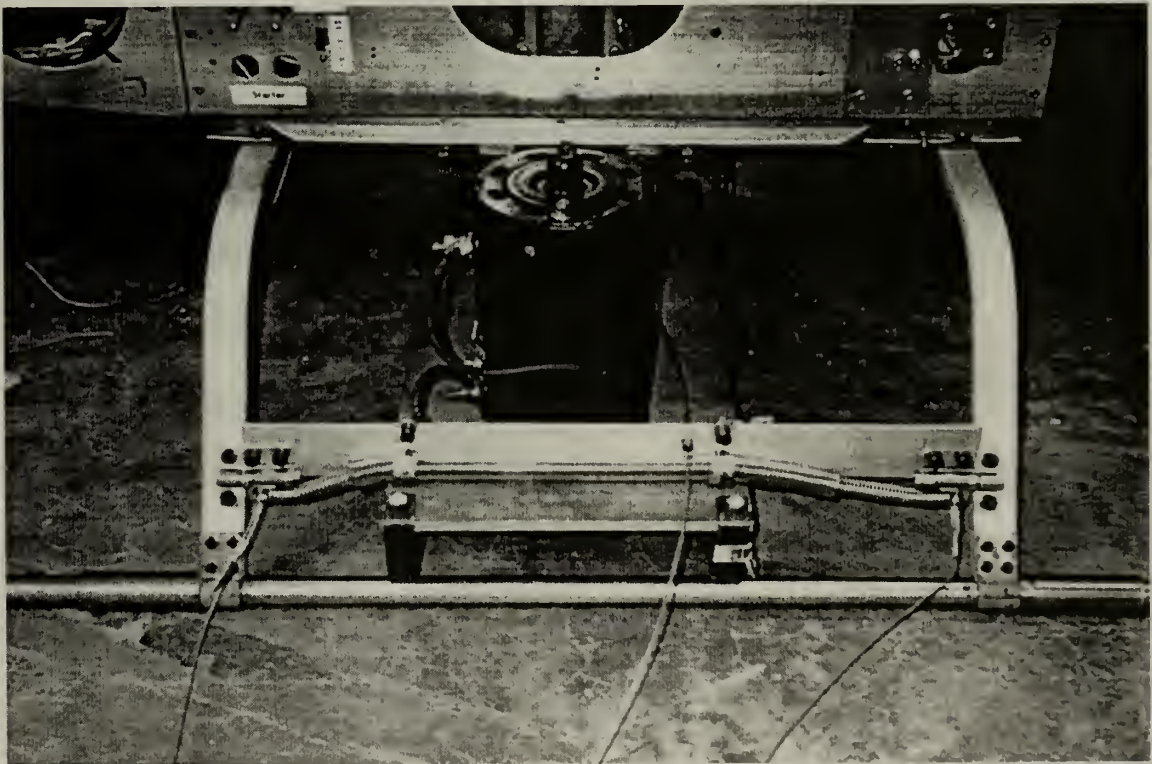
Figure 13. Starter Mounted to Landing Gear

The starter is held in place at four points shown in Figures 13 and 14 keeping entirely off the ground when attached for engine start. The first two are on each landing gear strut. Two pins and mechanical stops prevent fore and aft as well as lateral movement. These two

pins are connected by a spring so that both pins release after an over-the-center lock is cleared. The third point is the 3/8 inch hex ball socket which limits horizontal planar movement when coupled to the engine. The fourth point is a spring-loaded latch assembly connected to a cross bar under the engine which keeps the starter coupled to the engine during start. Two 30 foot lengths of small diameter cable are connected to the assembly which allows starter disengagement and towing the assembly clear of the operating area. Skids are installed to pull the assembly clear. The skids are formed with a semi-circular protrusion on the front. This feature unloads the 20 pound weight on the pins that hold the

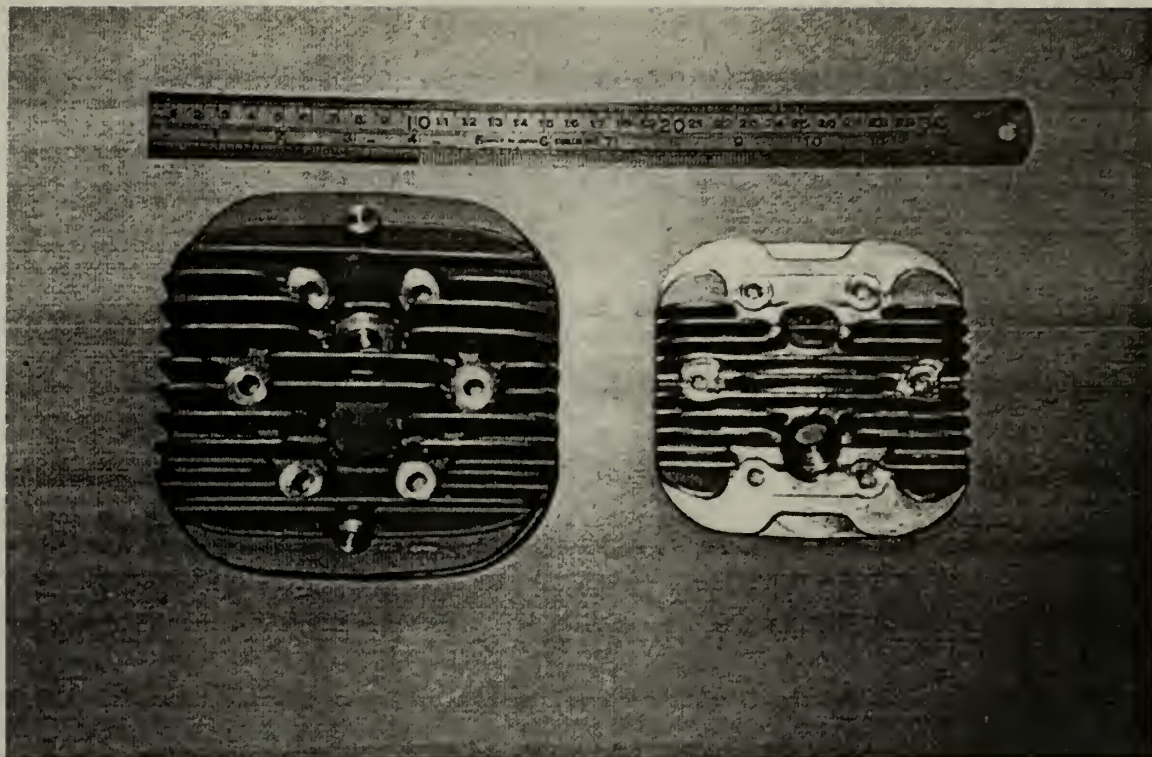
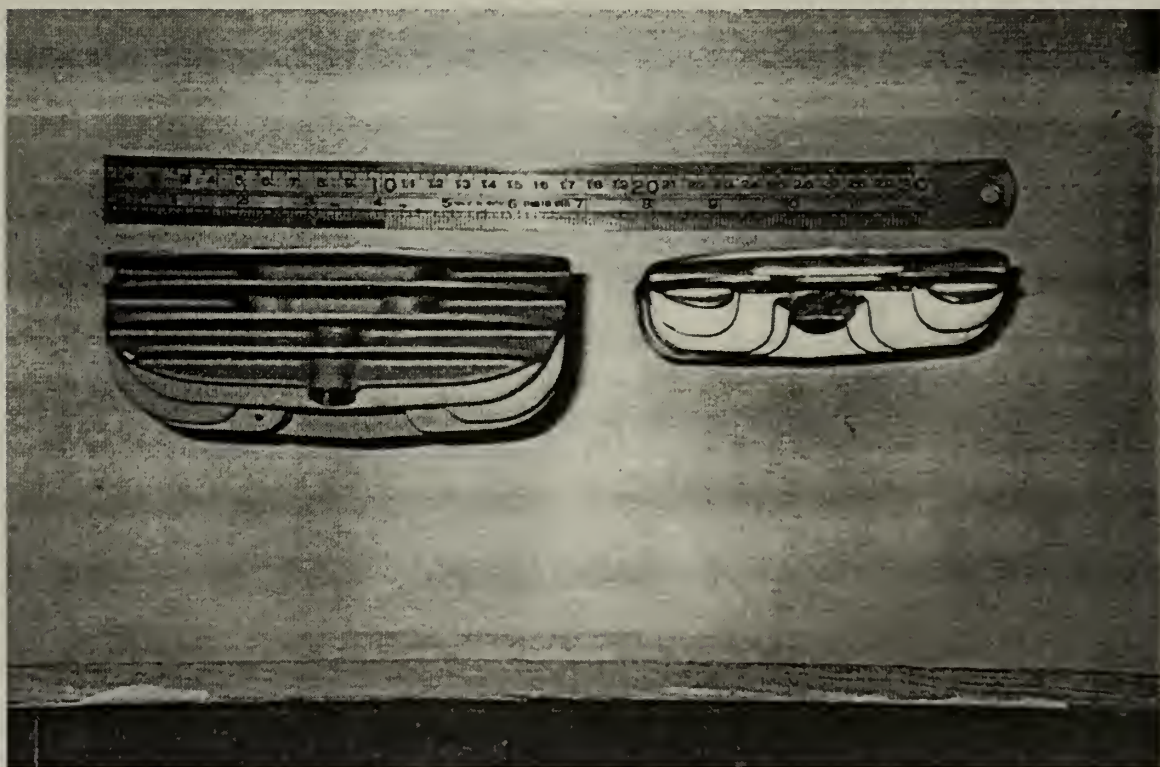
Figure 15. Size Comparison of Cylinder Heads.

As previously stated, the standard cylinder heads which was originally installed on the engine was replaced with the larger cylinder heads and are shown in comparison with each other in Figure 15. The effects of the improved heat dissipation through the significant increase in surface area have already been discussed. The larger heads required a standard size spark plug rather than the short plug used in the standard head. The engine manual called for a Bosch W6 BC spark plug with a 12.7 mm reach. An equivalent substitute plug, Splitfire SF 412C, was used due to the unavailability of the Bosch plug. The Splitfire plug has a smooth ceramic insulator where as other spark plugs have ridged ones. The smoothness caused the spark plug cap to slide off and disconnect during engine operation. To remedy this problem, retaining clips were installed to prevent the caps from working loose.

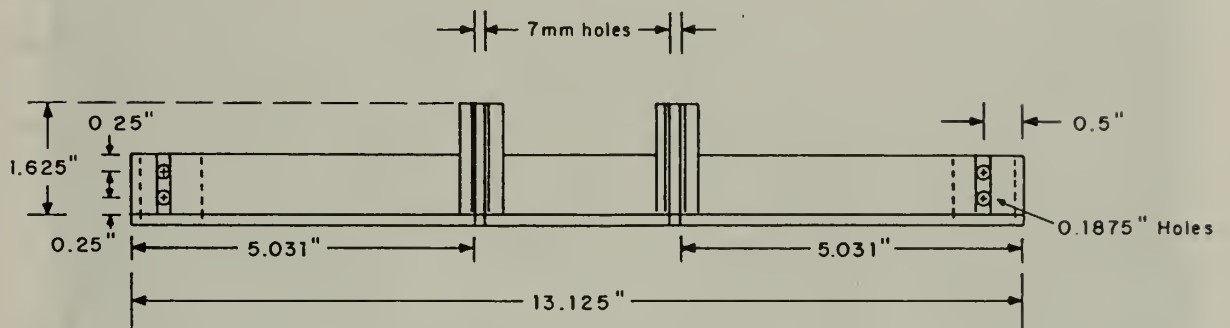
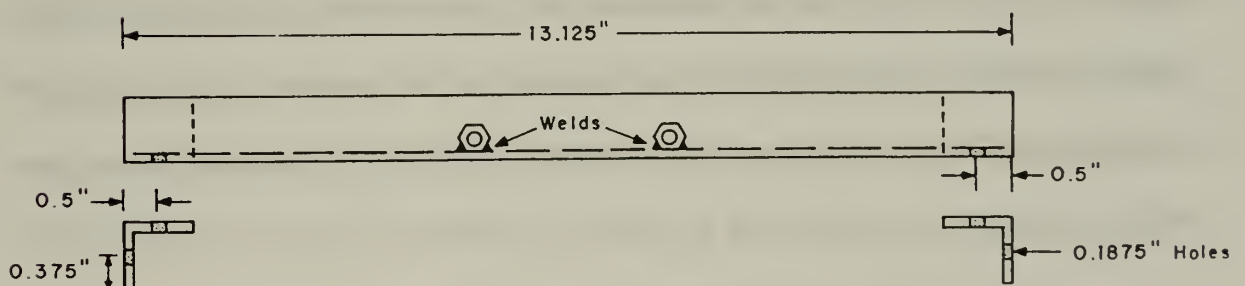
Figure 16. Upper Engine Mount

(1) Upper Engine Mount. As the engine required some minor modification on the test stand, the *Hummingbird* required some airframe modification to accommodate the new enlarged cylinder heads. The four engine mounting points on the bottom of the airframe remained unchanged; however, the upper engine mounting bracket that was installed as a part of LT Greg Fick's [ref. 3] modifications shown in Figure 16 had to be moved aft by at least 1.04 inches due to the difference in the cylinder head thicknesses. The two side stiffening plates were moved aft to provide the necessary airframe support for the bracket's new position.

The bracket modification led to another problem. The upper engine mount braced the engine through two of the six 6 mm cylinder head bolts. The existing cylinder head bolt was not long enough to provide support for the cylinder head and also pass through the upper engine mount. Attempts to find longer bolts and 6mm threaded rod failed as no local supplier carried the longer bolts or metric size threaded rod. As a result, two adapters which acted as a cylinder head bolt, spacer and upper engine mount attachment point were designed to custom fit this application. Figure 17 shows this piece. The cylinder head bolt segment is 6 mm in diameter and includes the correct cylinder head bolt thread length. The spacer was designed to provide a gap between the cylinder head and upper mount brace so there will be no damage inflicted on the cylinder head heat fins while the both the engine and airframe vibrate. The remainder consists of the mounting bracket threads which are also 6 mm in diameter.

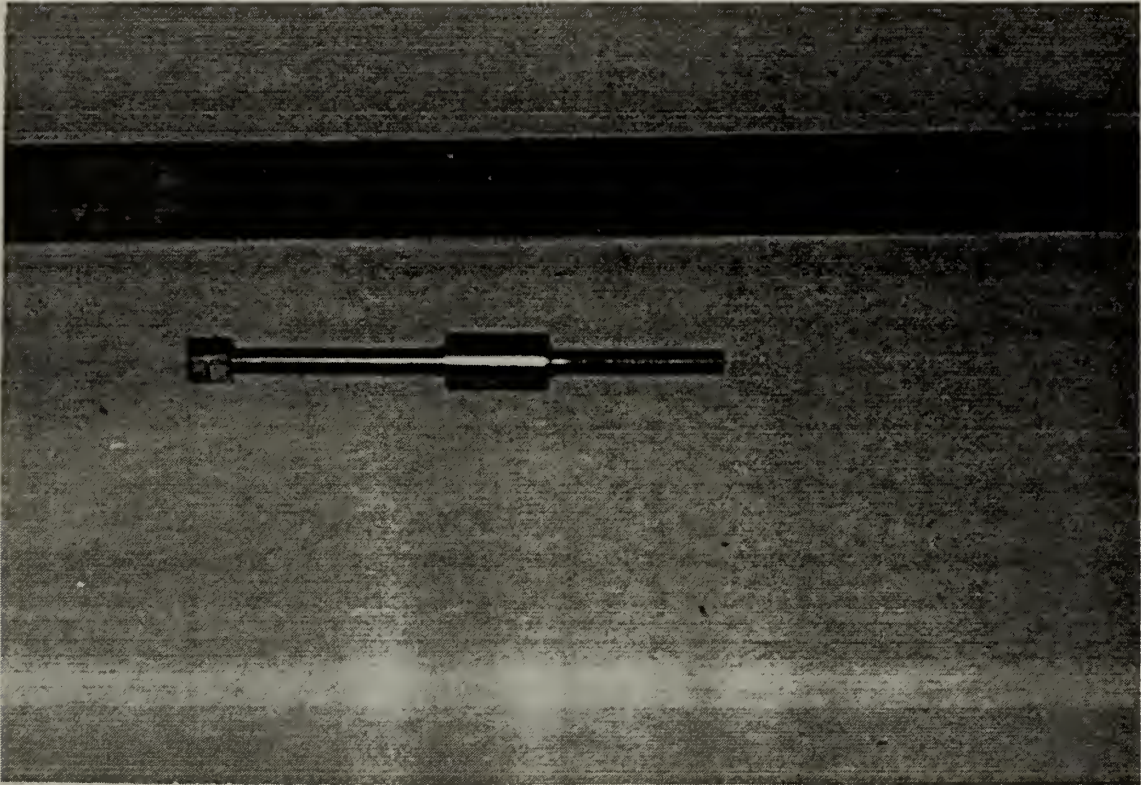
Figure 17. Spacer Bolt

(2) Adapter Installation. To install the adapter the cylinder head bolt portion is first screwed in to place. To accomplish this two nuts must be locked

against each other on the mounting bracket end and then the whole piece torqued to the cylinder head bolt torque specification. The two nuts are then removed and the mounting bracket is then slid over the free end. The mounting bracket is then secured by a two lock washers and nuts.

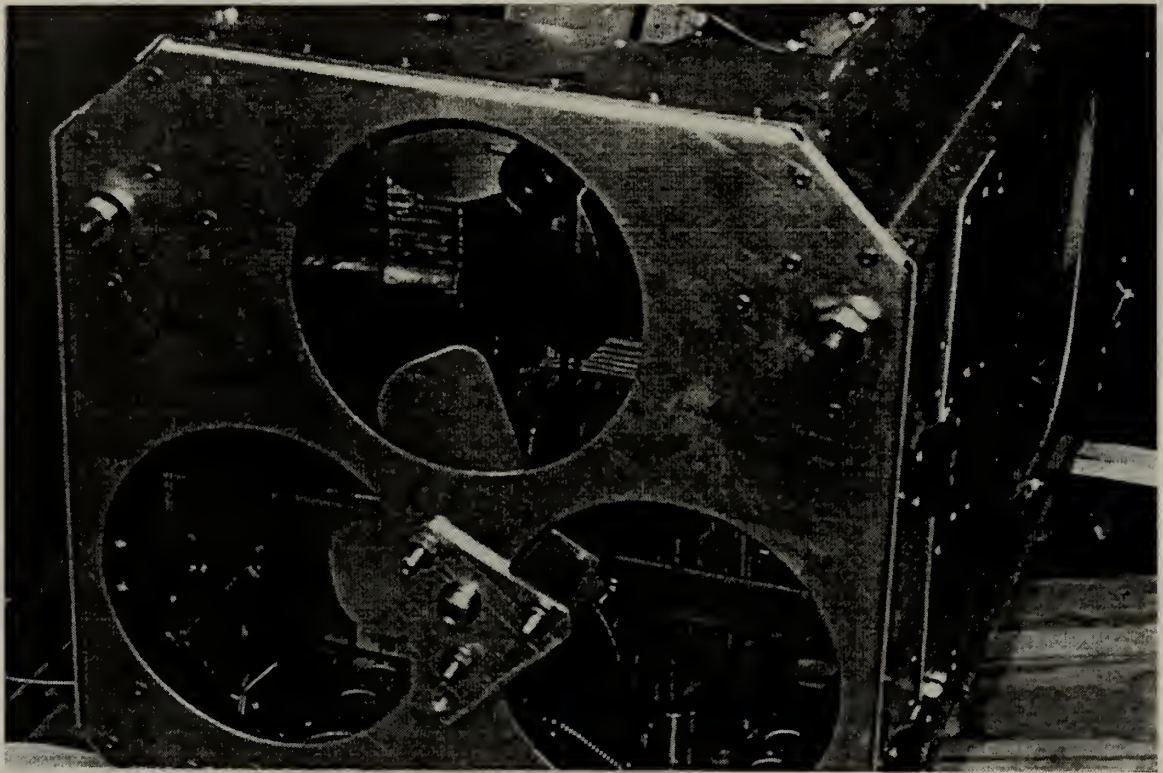
Figure 18. Cooling Fan and Drive Configuration

After considering many options of cooling fans, configurations and suggestions from industry, a simple and reliable design was implemented. The cooling air velocity through the engine compartment was observed during the engine tests and a system to move air through at this speed was introduced. Two air-conditioning condenser fans rated at 500 cfm at 3000 rpm were purchased for less than \$6.00 and mounted to ventilate the new 1.3 cubic foot engine compartment. One fan was modified to fit on the tail rotor drive take-off shaft off the main transmission which rotates at 40 percent of the engine rpm or 1200 to 2800 rpm. The other fan was mounted to the rear wall of the engine compartment. As shown in Figure 20, the lower fan is driven by a belt drive configuration and rotates at the same rpm as the tail rotor drive shaft. The tail rotor shaft mounted fan provides cooling air primarily to the forward cylinder while the belt driven fan provides ventilation to the aft cylinder.

Information on this fan was unavailable. Measurement of the cooling fan air flow at 1500 rpm (approximate fan rpm at engine idle) showed approximately 345 cfm. Assuming a linear increase in air flow with increasing rpm as seen in several other fan

performance charts, the air flow at 2800 rpm is estimated at 480 cfm. Thus the two fans together produce 960 cfm at 7000 engine rpm through the engine compartment which exceeds the air flow pattern seen on the engine test stand.

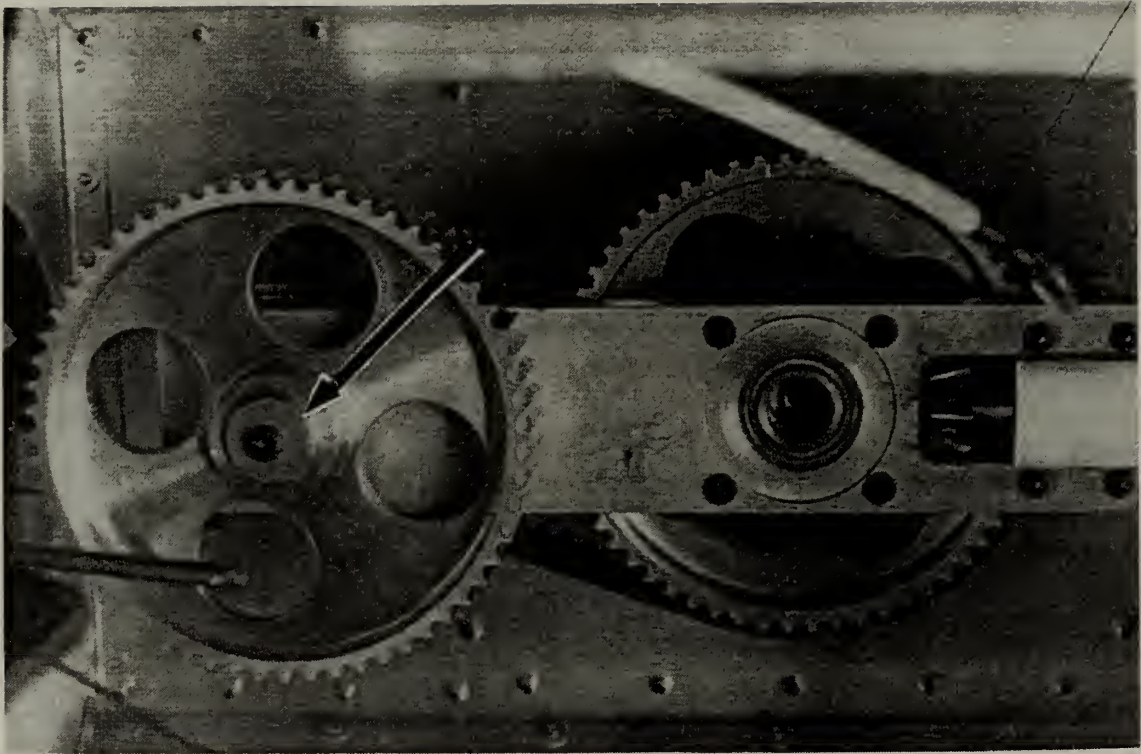
Figure 19. Intermediate Shaft of the Main Transmission

The intermediate shaft on the transmission shown in Figure 19 was selected as the location for the shock absorber assembly. The shock absorber itself is a Metalastik®

Rotoflex® coupling. It consists of a hexagon of rubber with six metal inserts bonded into position. It also contains metal interleaves bonded into the rubber for increased torque capacity when required. The coupling must be able to withstand a 76.8 ft-lb sustained load plus a 32 ft-lb impulse load totaling a maximum load of 108.8 ft-lbs. The 76.8 ft-lb moment was obtained by using the maximum torque rating of 24 ft-lbs and multiplied by 3.2 for the load at the intermediate shaft. . A coupling closest to this specification was ordered. This size coupling gives a safety margin of 1.33 computed for rated maximum torque to estimated

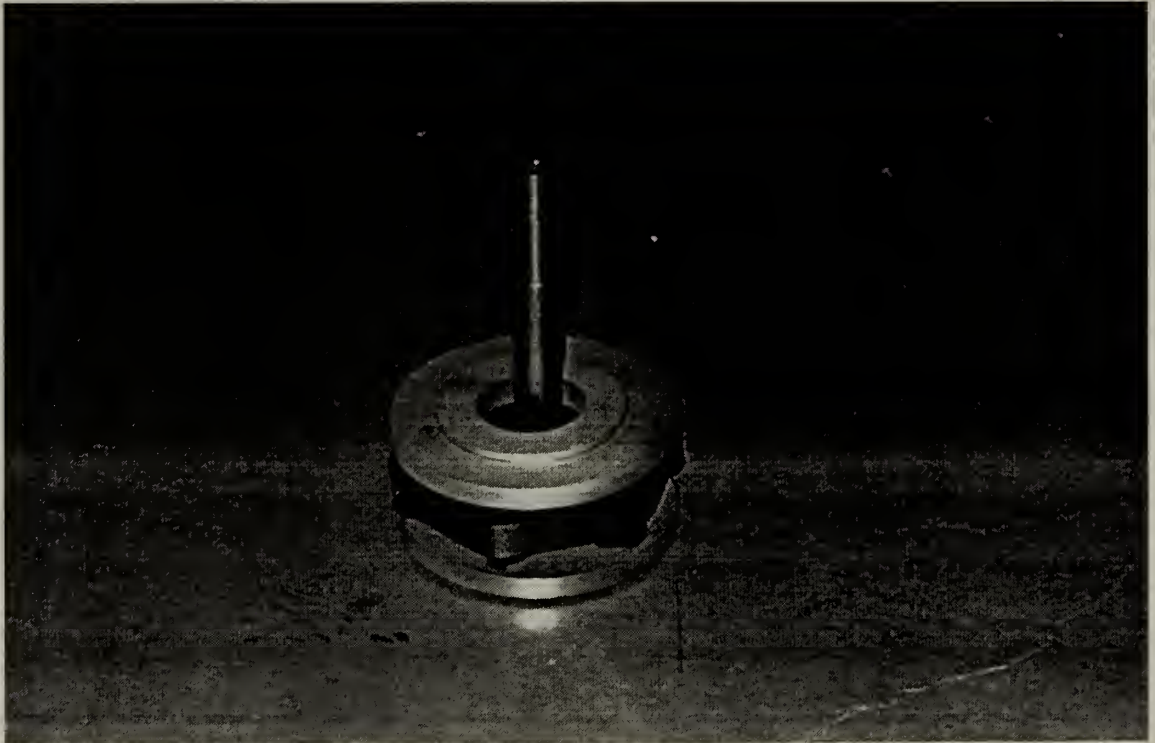
Figure 20. Layout of Shock Absorber Components

unfinished components of the shock absorber system in the position they are to be mounted. The drawings in appendix D show the final form of the upper and lower plates, spacer ring and modified drive shaft.
